**SLUDGE & RESIDUAL FUEL
REMOVAL**

TANK CLEANING PROGRESS

****Info current as of May 27, 2025***

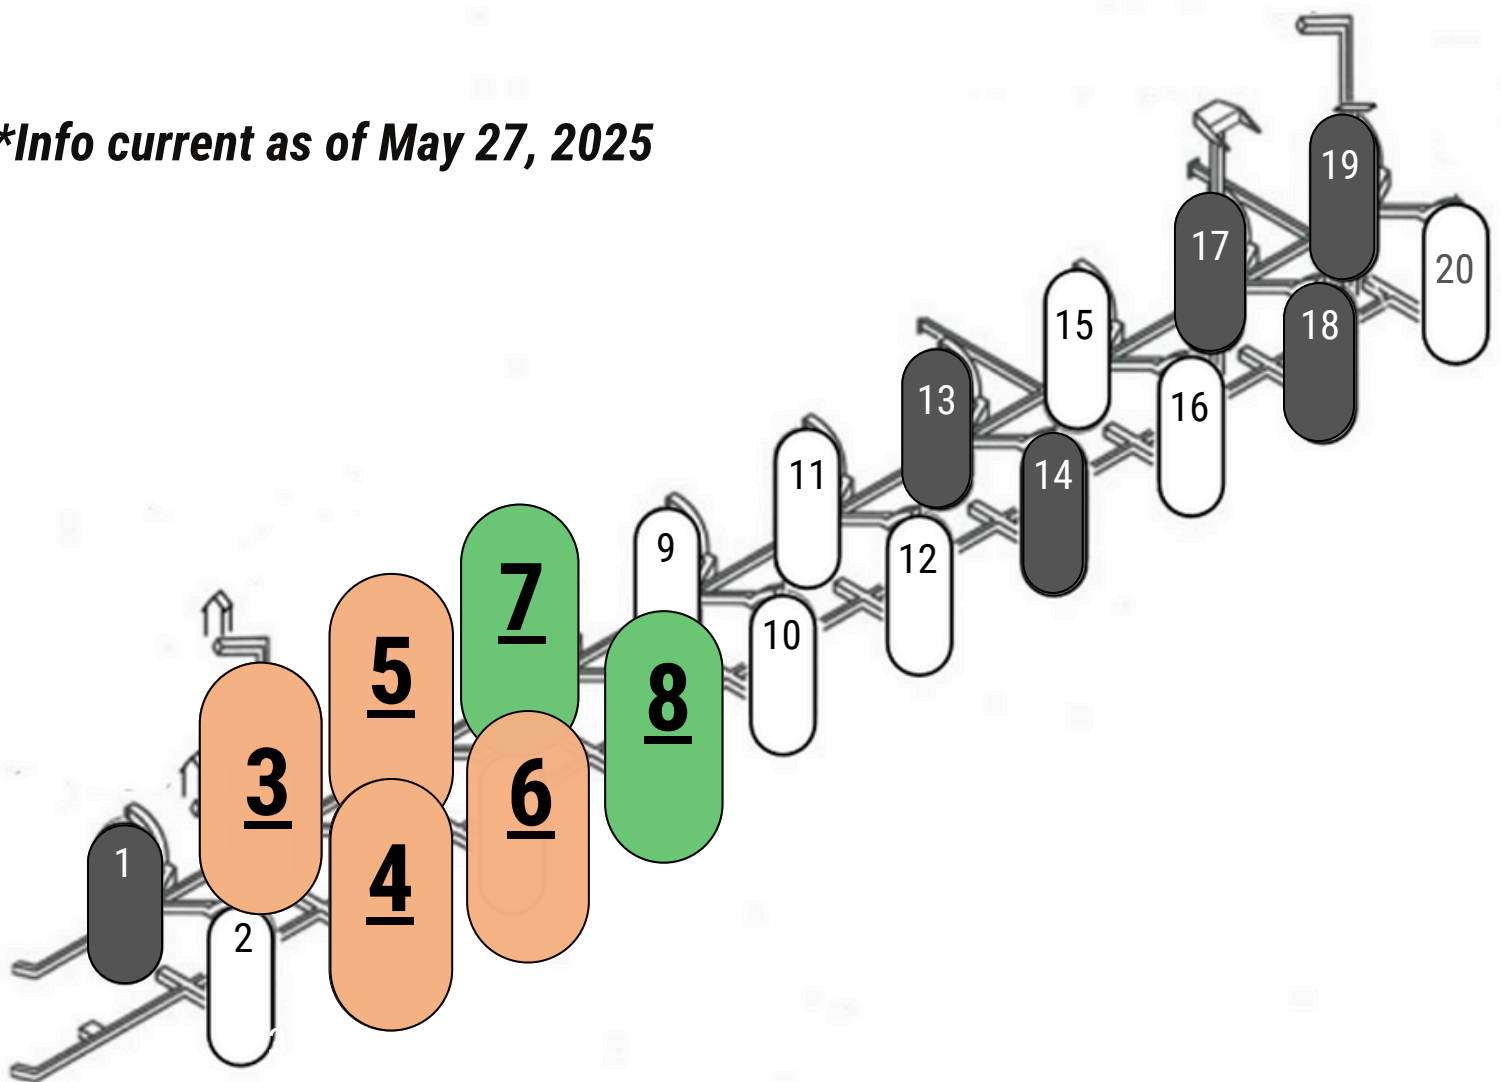
☐ **Step 1 – Preparation** (Approx. 2-3 months):

- Isolate tank and disconnect piping
- Install tank ventilation equipment and inject water to soften sludge
- Remove flowable sludge
- Begin tank ventilation with forced air

☐ **Step 2 – Remove Solid Sludge** (Approx. 2-3 months):

- Inspect and repair central tower and catwalk
- Install center tower elevator; load test tower and catwalk
- Remove solid sludge

☐ **Step 3 – Pressure Washing** (Approx. 1-2 months):

- Set up pressure washing system and
- Pressure wash with 3% Simple Green
- Rinse, continuously removing rinsate
- Dry tank interior and validate cleanliness; submit cleaning report
- Receive regulatory agency final approval that tank is clean

☐ **Step 4 – Tank Decommission** (Approx. 1-2 Months):

- Remove booms and infrastructure
- Install permanent lockable steel hatch at the entrance

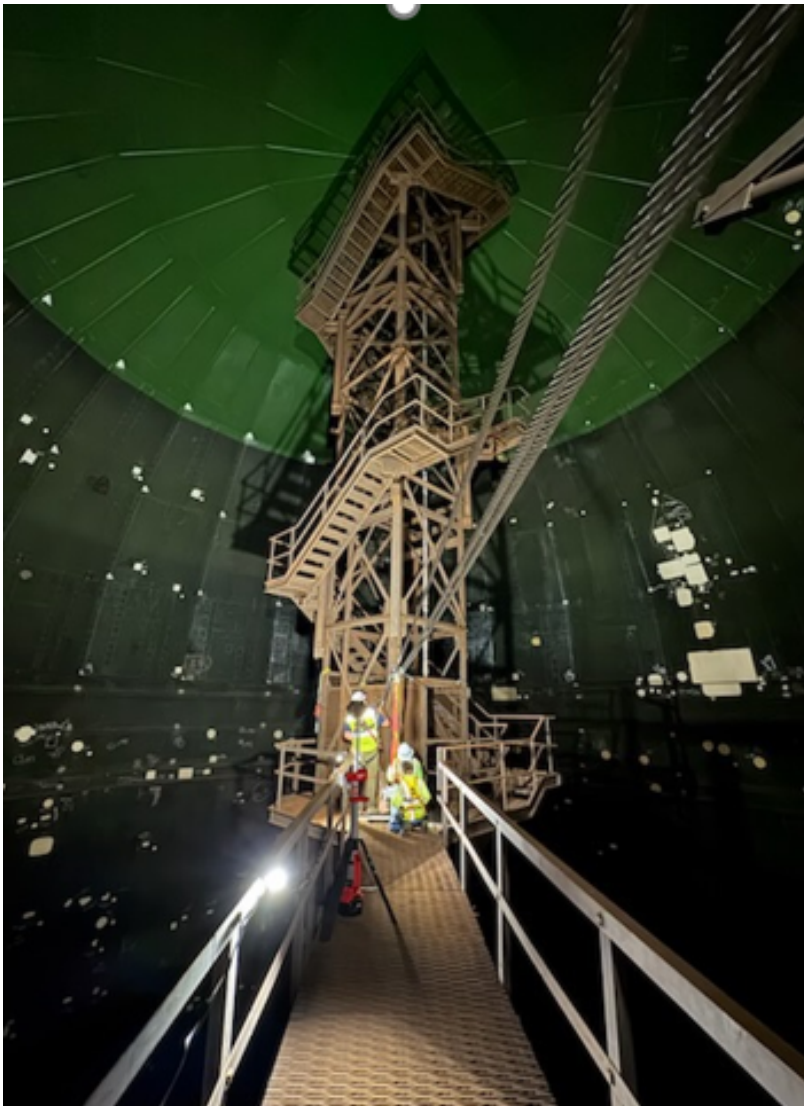
TANK 6

Structural assessments are ongoing for a spiral staircase that is unique to Tank 6. Its removal is required for safe tank cleaning.
